CRITICAL LIFE PREDICTION RESEARCH ON BORON-ENHANCED Ti-6Al-4V

THESIS

Kevin A. Schwendiman, First Lieutenant, USAF AFIT/GAE/ENY/07-J24

AIR FORCE INSTITUTE OF TECHNOLOGY

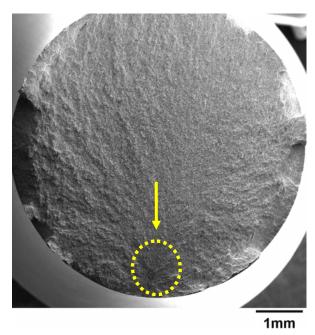
Figure 4.3: Fracture surface for fatigue specimen tested at 896 MPa failing at 4,485 cycles.

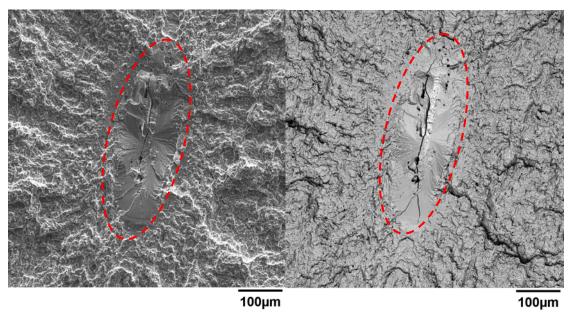
Figure 4.4: Inclusions shown in secondary imaging on left and backscatter imaging on right for fatigue specimen tested at 896 MPa failing at 4,485 cycles.

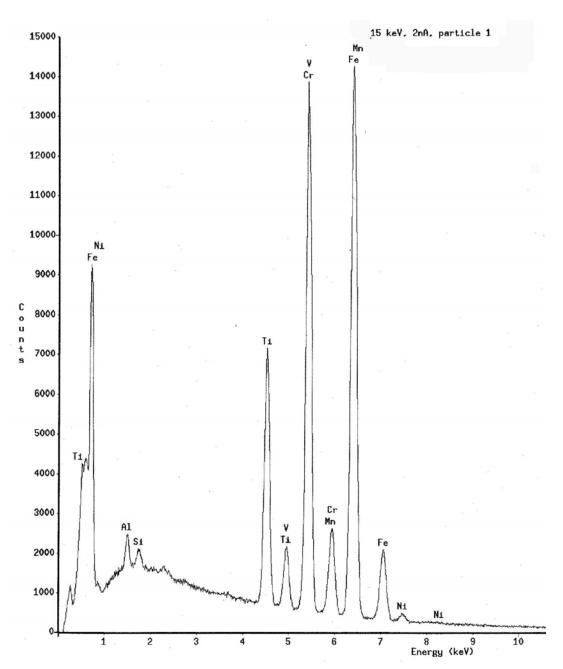
Figure 4.6: EDS x-ray analysis of inclusion flaw on fracture surface of Ti64+1B specimen tested at a stress of 896 MPa failing at 4,485 cycles.

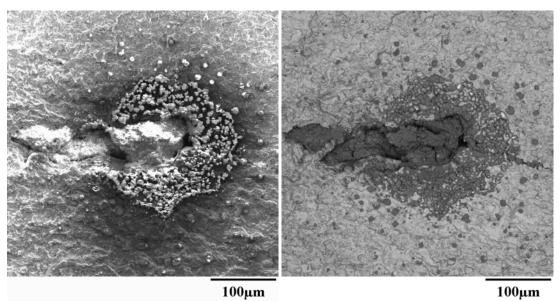
Figure 4.7: Secondary (left) and backscatter images of fracture surface for Ti64+1B specimen tested at 758 MPa and failing at 9,629 cycles.

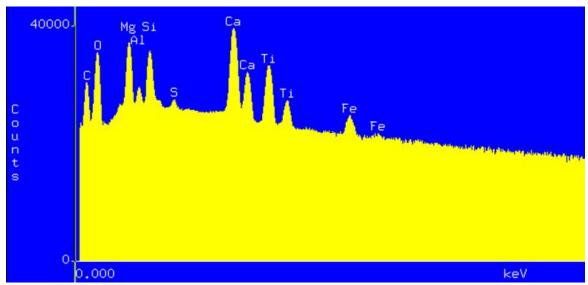
Figure 4.8: EDS spectrograph of center of inclusion in Ti64+1B specimen tested at 758 MPa and failing at 9,629 cycles.

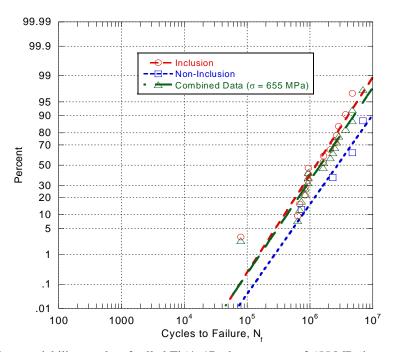
The extent to which inclusions in the Ti64+1B rolled plate material affected the variability in fatigue life is demonstrated in POF plots for the two lower variability stresses in Figures 4.11 and 4.12. Here, each data set is broken into two populations. One data set represents the specimens that didn't fail at inclusions and the other set represents the specimens that did fail at inclusions. For the lower stress in Figure 4.11, the combined data had a 0.1% POF at about 60,000 cycles. Most of the failure initiation

sites at the lower stress were from inclusions but without the inclusions the cycle count at the 0.1% POF doubled to about 120,000. At the middle stress in Figure 4.12, filtering out the inclusions also resulted in doubled the 0.1% POF prediction from around 9,000 to 20,000 cycles. Furthermore, a 0.1% POF for the inclusion data only of both lower stresses was carried out. In the lowest stress case, the effect was negligible. However, at the middle stress of 758 MPa in Figure 4.12, a disastrous near zero cycle count was predicted. The POF inclusion extrapolation at the middle stress is based only upon three data points so this prediction carried little impact but could be interpreted as a major warning concerning the threat that inclusions pose on the lower limit to fatigue variability.

Figure 4.11: Fatigue variability results of rolled Ti64+1B plate at stress of 655 MPa in terms of probability of failure. The mechanism of inclusion is separated from the other data to demonstrate its affect upon the fatigue life.

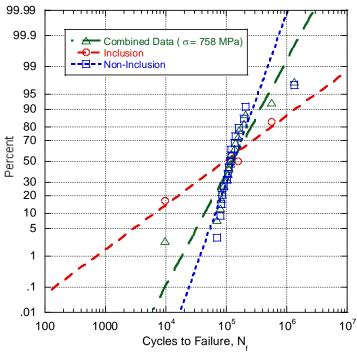
Figure 4.12: Fatigue variability results of rolled Ti64+1B plate at stress of 758 MPa in terms of probability of failure. The mechanism of inclusion is separated from the other data to demonstrate its affect upon the fatigue life.

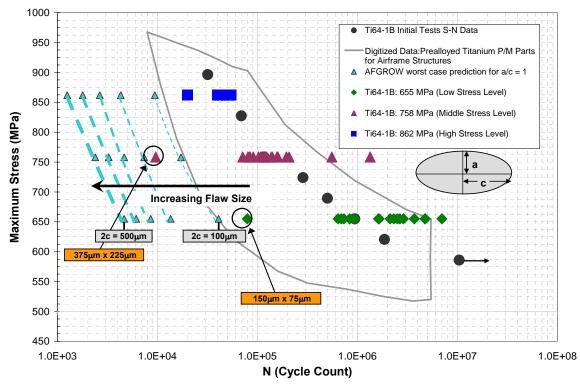
The S-N fatigue results were placed side by side with the results of the AFGROW analysis in Figures 4.22, 4.23, 4.24, and 4.25 for the three a/c embedded flaw cases and the surface flaw case. From fractography, the dimensions of the lowest life specimen at the middle stress of 758 MPa (labeled in all four figures) were approximately 375 by 225 μ m. This equates to a/c = 0.6. This subsurface flaw had a fatigue life of 9,629 cycles. Using Figure 4.23 with a/c = 0.5, a 2c = 300 μ m embedded flaw corresponds to an N_f of about 7,000 cycles and a 2c = 400 μ m embedded flaw corresponds to an N_f of 5,000 cycles. The prediction using Figure 4.22 with a/c = 1 at the same flaw sizes yields a N_f range of 5,000 down to 3,000 cycles. A worst case result for this flaw at a/c = 0.6 could be interpolated between the a/c = 0.5 and a/c = 1 data. The close enough results of this are analysis show that the FCG analysis using AFGROW has accurately predicted and

captured both the worst case fatigue life and the detrimental effect of the life-limiting damage mechanism: inclusions.

The other data point circled in Figures 4.22, 4.23, 4.24, and 4.25 is for the specimen at the low stress of 655 MPa that failed at 79,720 cycles. Although the result for this specimen is still safely away from the left edge of the digitized envelope, fractography showed that an inclusion near the outside of the specimen caused this specimen to fail. In addition, nearly an order of magnitude separates this data point from the next point at this stress level. The flaw and resulting initiation site had dimensions of approximately 150 μ m by 75 μ m. Assuming the worst case, an inclusion at the surface, and estimating between the $2c = 200 \mu$ m and the $2c = 100 \mu$ m curves, the N_f would have been between 10,000 and 20,000 cycles. This is five times less than the actual fatigue life but Figure 4.25 still demonstrates that inclusions allowed by a -35 mesh sieve (up to 500 μ m) could result in poor life fatigue lives below 10,000 cycles for the Ti64+1B material system.

Figure 4.22: Comparison of fatigue variability results with AFGROW's elliptical embedded flaw prediction at a/c = 1.

Clearly, a cleaner Ti64+1B material produced via powder metallurgy using a smaller mesh size would be more competitive for aerospace applications. The current life limiting mechanism's influence on the fatigue lower limit and crack initiation character as well as the risk of premature failure can be substantially reduced. These improvements could be realized by repeating the analysis of this thesis for the next generation Ti64+1B material.

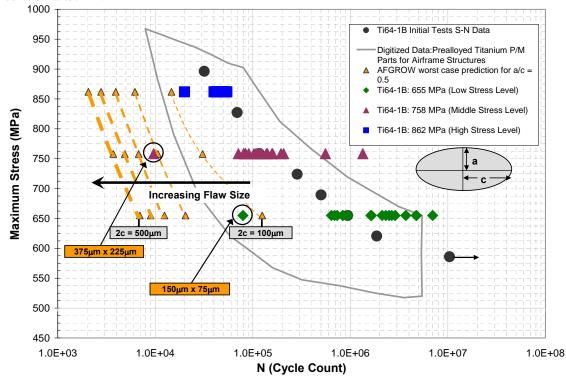
Figure 4.23: Comparison of fatigue variability results with AFGROW's elliptical embedded flaw prediction at a/c = 0.5.

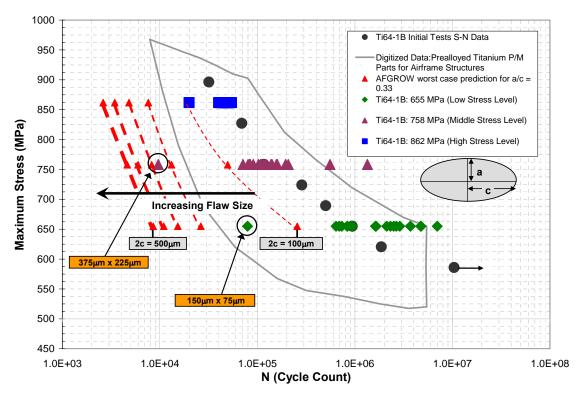
Figure 4.24: Comparison of fatigue variability results with AFGROW's elliptical embedded flaw prediction at a/c = 0.33.

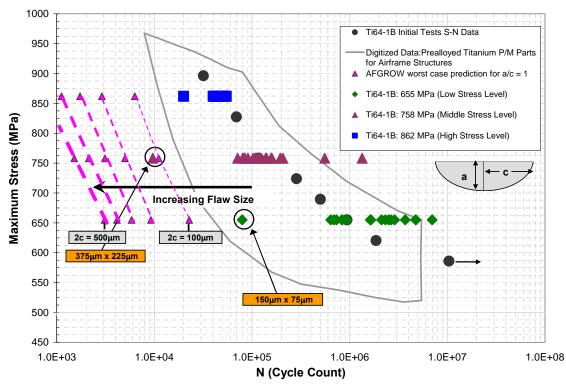
Figure 4.25: Comparison of fatigue variability results with AFGROW's semi-elliptical surface flaw prediction at a/c = 1.

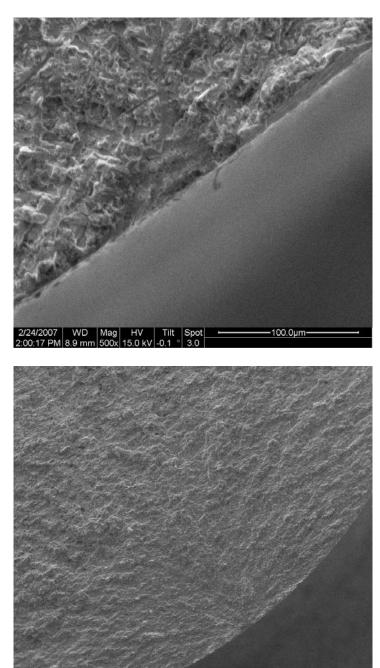
σ = 655 MPa, N_{Low} = 79,270 (Near surface inclusion)

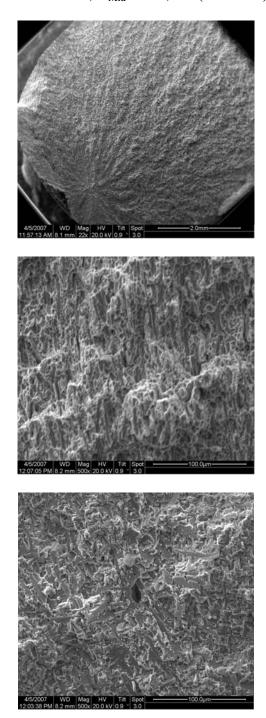
$\sigma = 655$ MPa, $N_{Mid}\!=640,\!185$ (Inclusion)

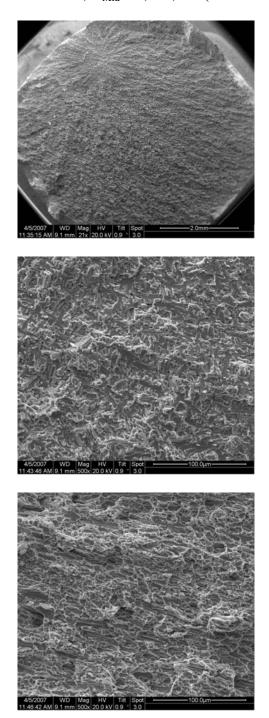
$\sigma = 655 \text{ MPa}, N_{Mid} = 2{,}122{,}964 \text{ (Inclusion)}$

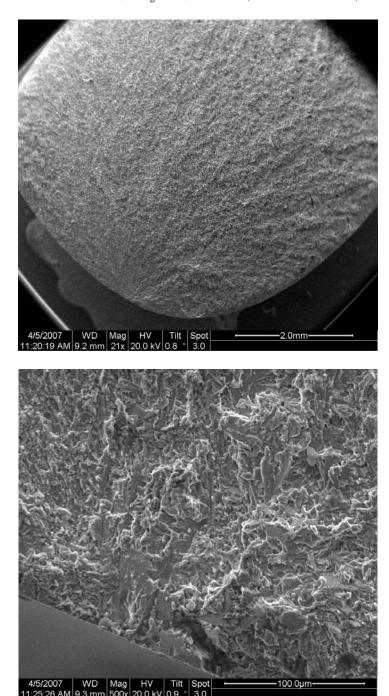
$\sigma = 655$ MPa, $N_{High} \! = 6,\!985,\!294$ (Not an inclusion)

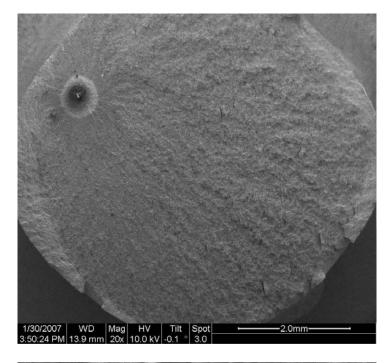
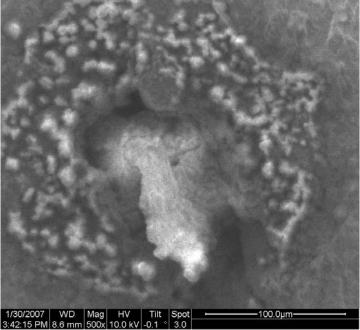
$$\sigma$$
 = 758 MPa, N_{Low} = 9,629 (Inclusion)

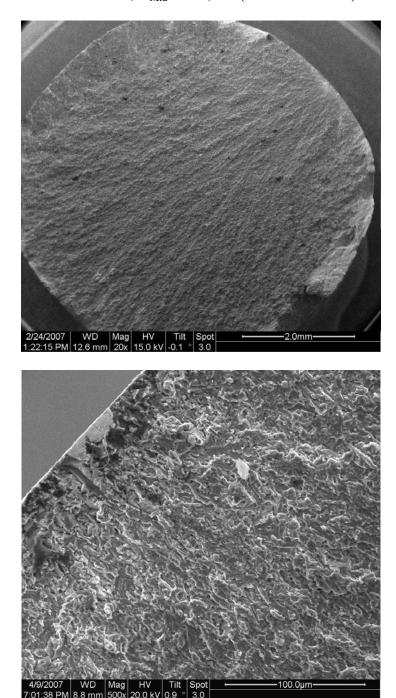
σ = 758 MPa, N_{Mid} = 194,626 (Not an Inclusion)

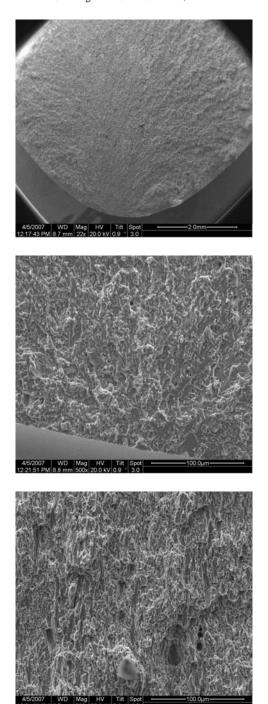
$\sigma = 758$ MPa, $N_{High} \! = 1,\! 342,\! 920$ (Not an Inclusion)

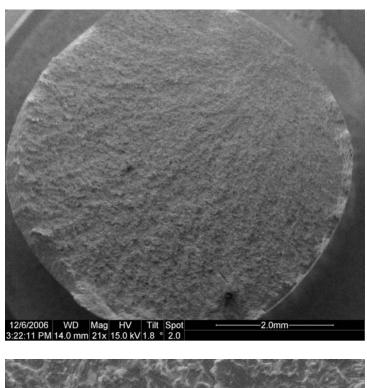
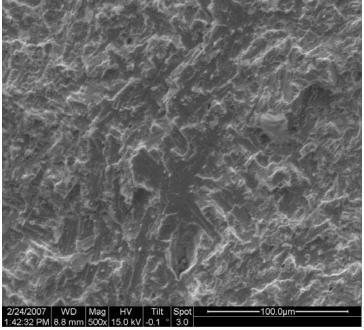
σ = 862 MPa, N_{Low} = 19,959 (Inclusion)

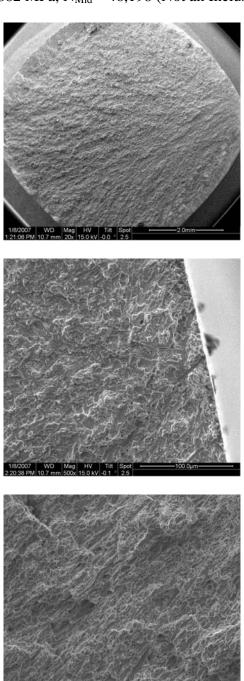
σ = 862 MPa, N_{Mid} = 46,198 (Not an Inclusion)

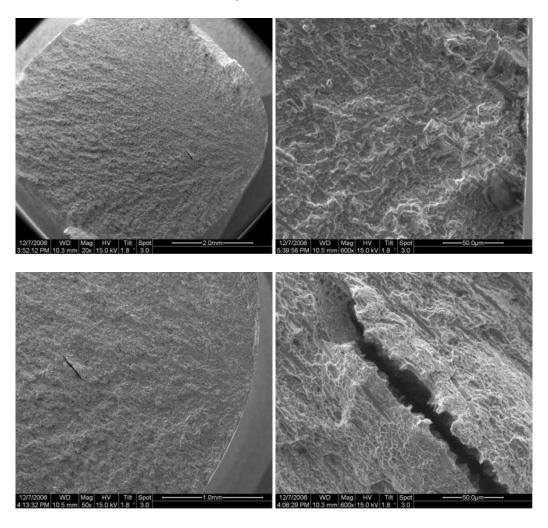
σ = 862 MPa, N_{High} = 54,434 (Not an Inclusion)
